Environmental Noise Monitoring

**91 Street Earth Berm Removal
in
Edmonton, Alberta**

Prepared for the
City of Edmonton
Drainage Services Branch

aci Project #: 14-072
October 01, 2015

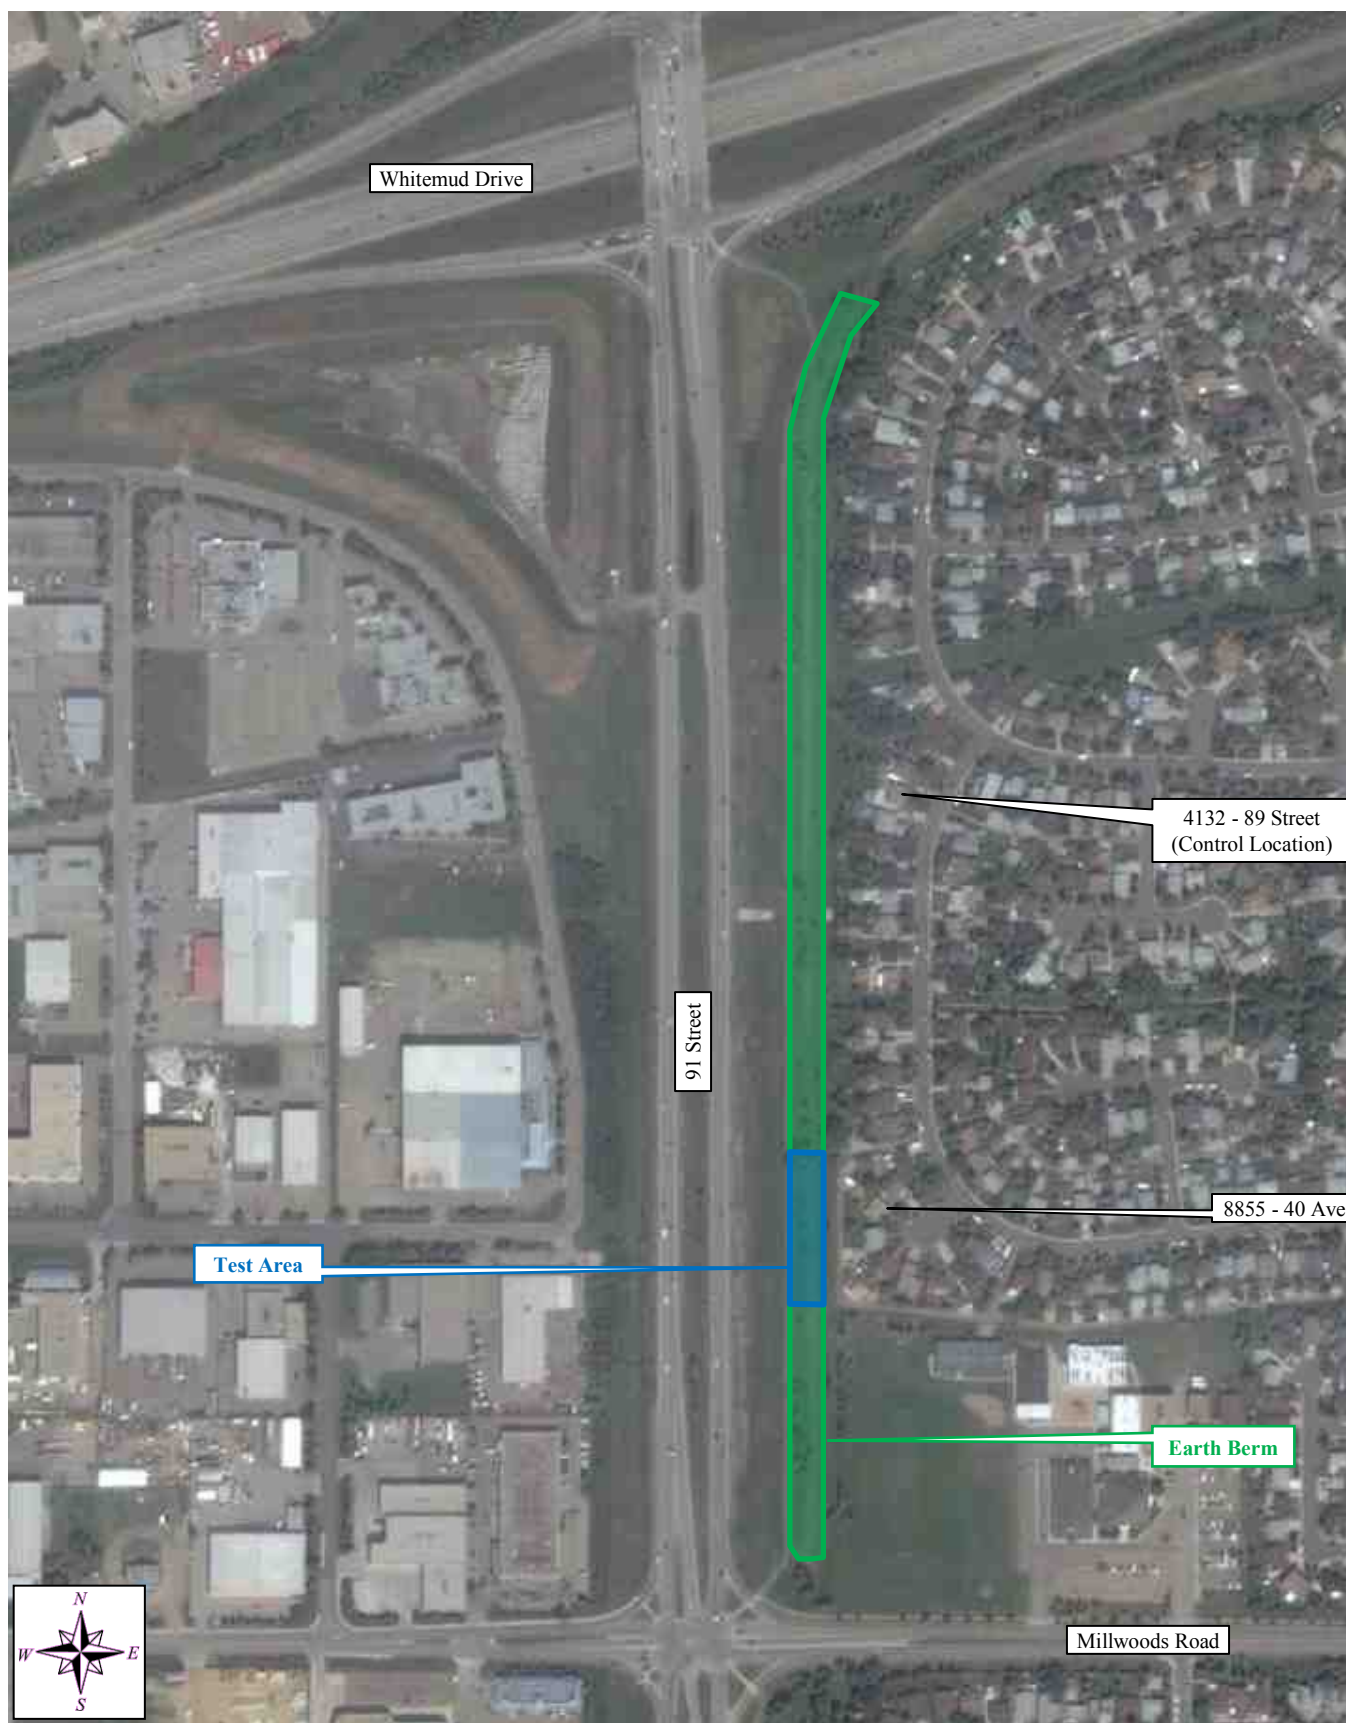
Figure 1. Study Area

The study area is located in the north Millbourne area of Edmonton, as shown in [Figure 1](#). The City of Edmonton Drainage Services is proposing to remove the existing earth berm located east of 91 Street to the north of Millwoods Road for the purposes of expanding the existing storm water management pond. The initial stage of the Project involved a test section with a portion of the earth berm removed and replaced with the vegetative style noise and visual barrier. As indicated in [Figure 2](#), the test section started at the south end from the alleyway to the south of 40 Avenue and spanned approximately 137 m to the north. This was directly behind the three houses in the cul-de-sac on 40 Avenue and 88 Street which back onto 91 Street.

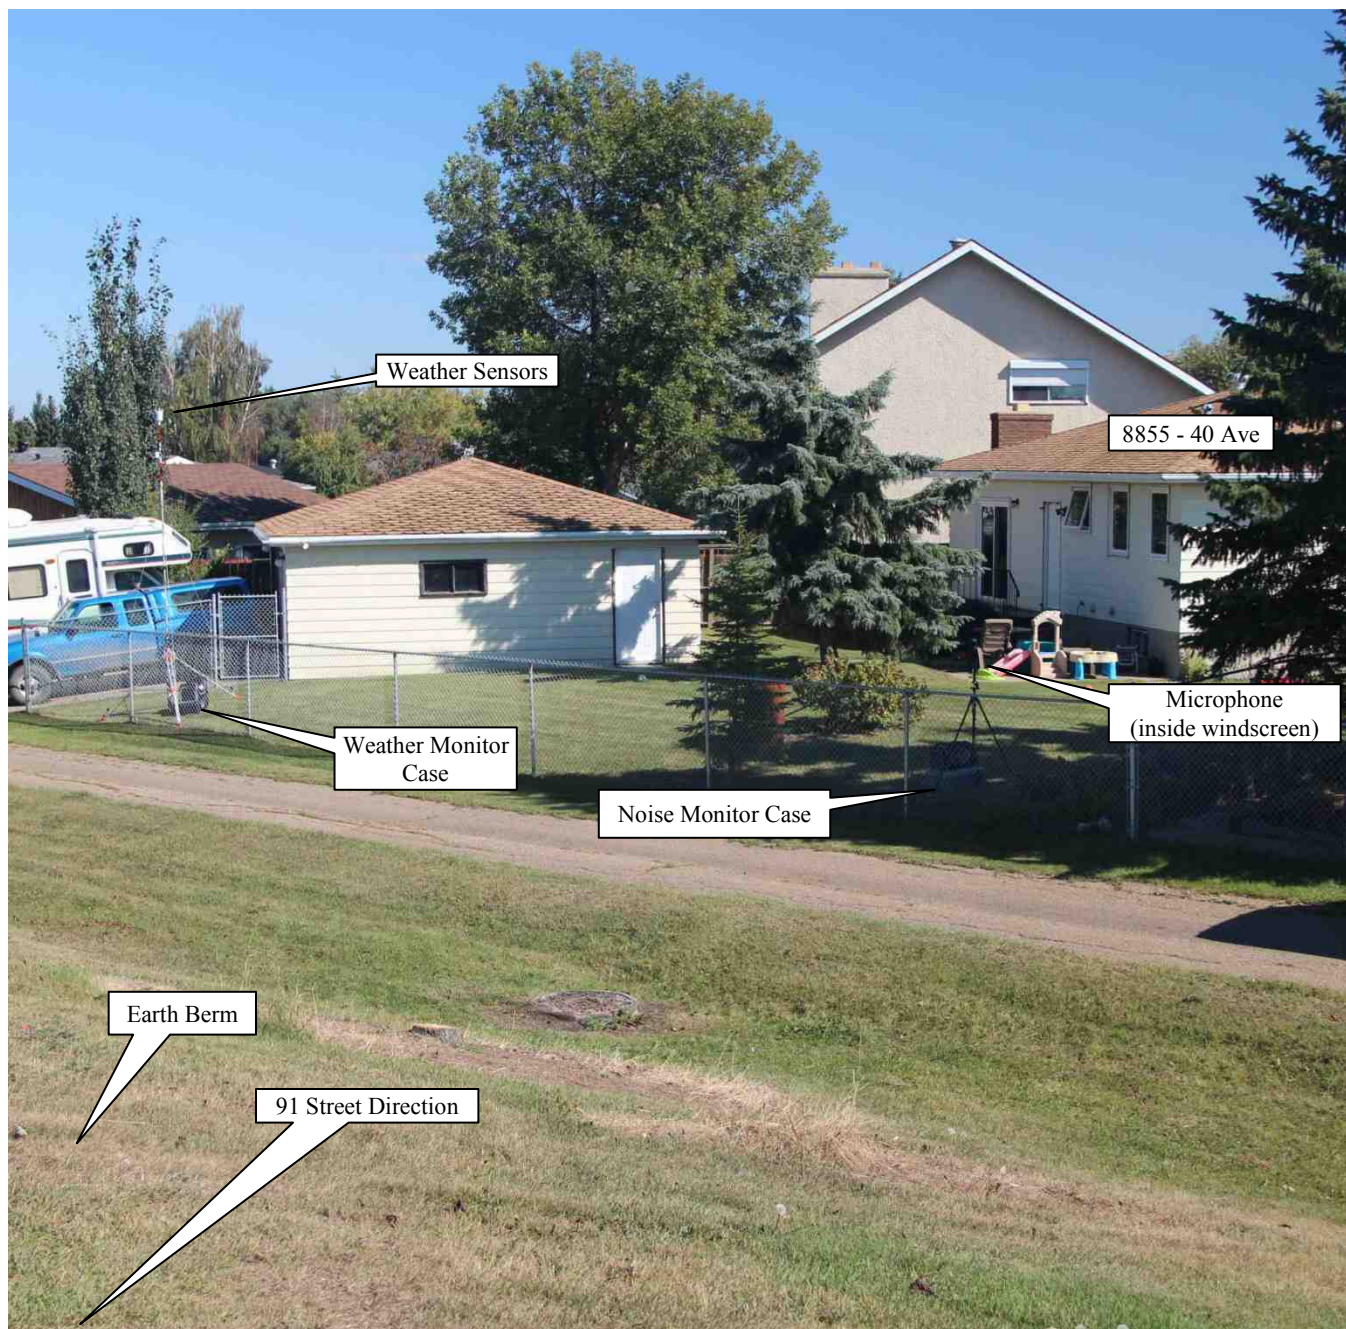
Figure 4. Picture of Noise Monitor at 8855 - 40 Avenue (Fall, 2014)

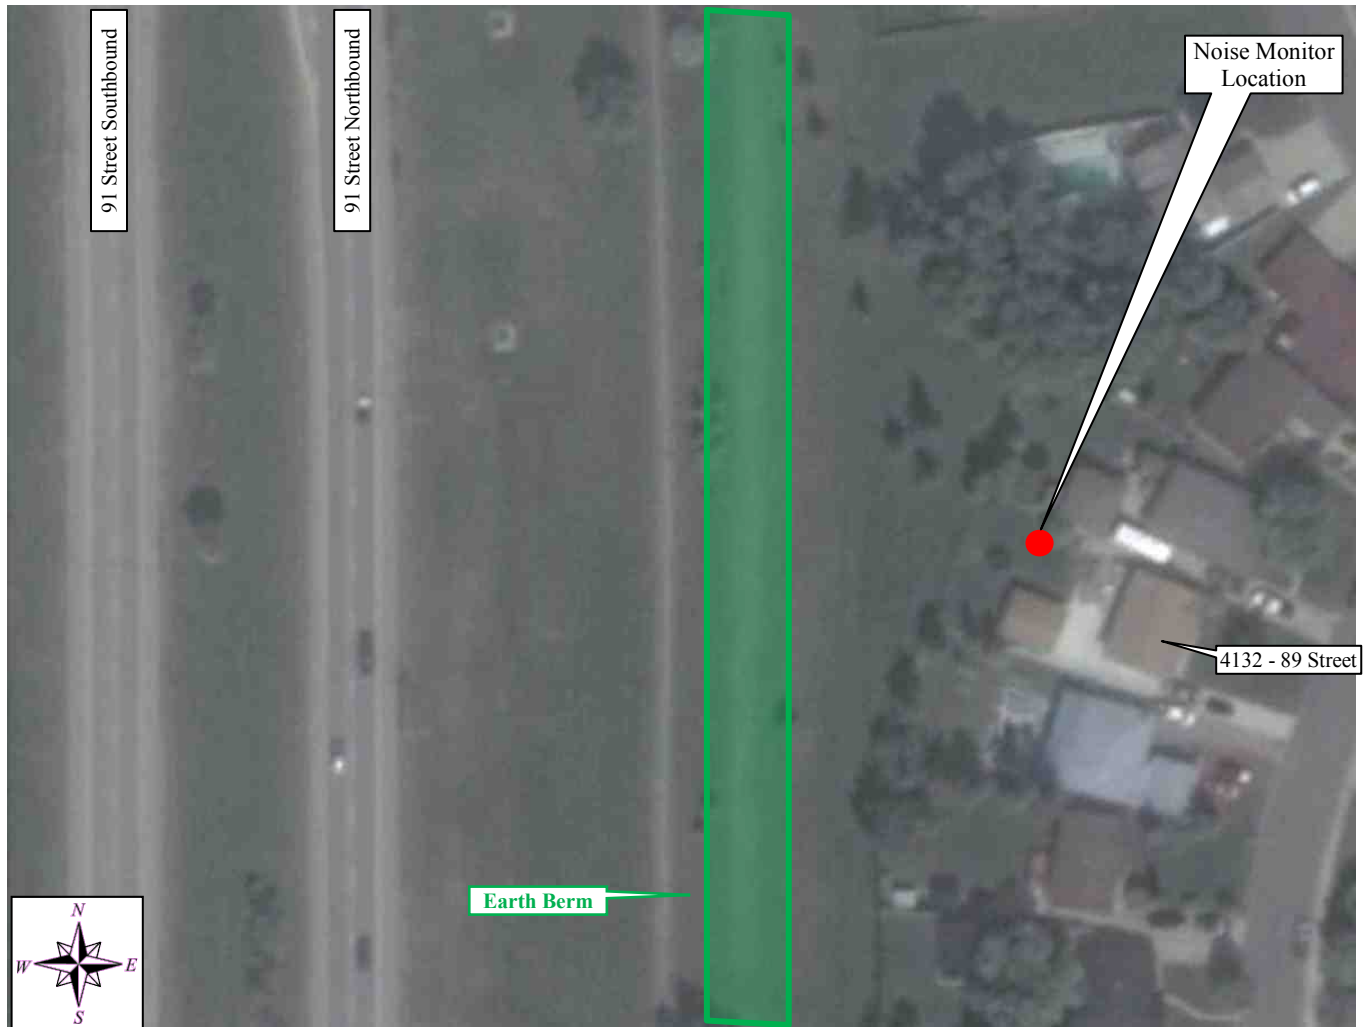
Figure 7. Noise Monitor Location at 4132 - 89 Street

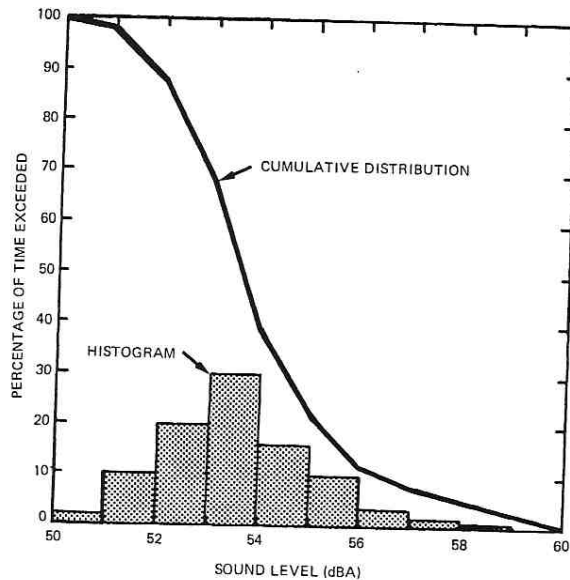
Figure 16.6 Statistically processed community noise showing histogram and cumulative distribution of A weighted sound levels.

Another method of conveying long term noise levels utilizes statistical descriptors. These are calculated from a cumulative distribution of the sound levels over the entire measurement duration and then determining the sound level at xx % of the time.

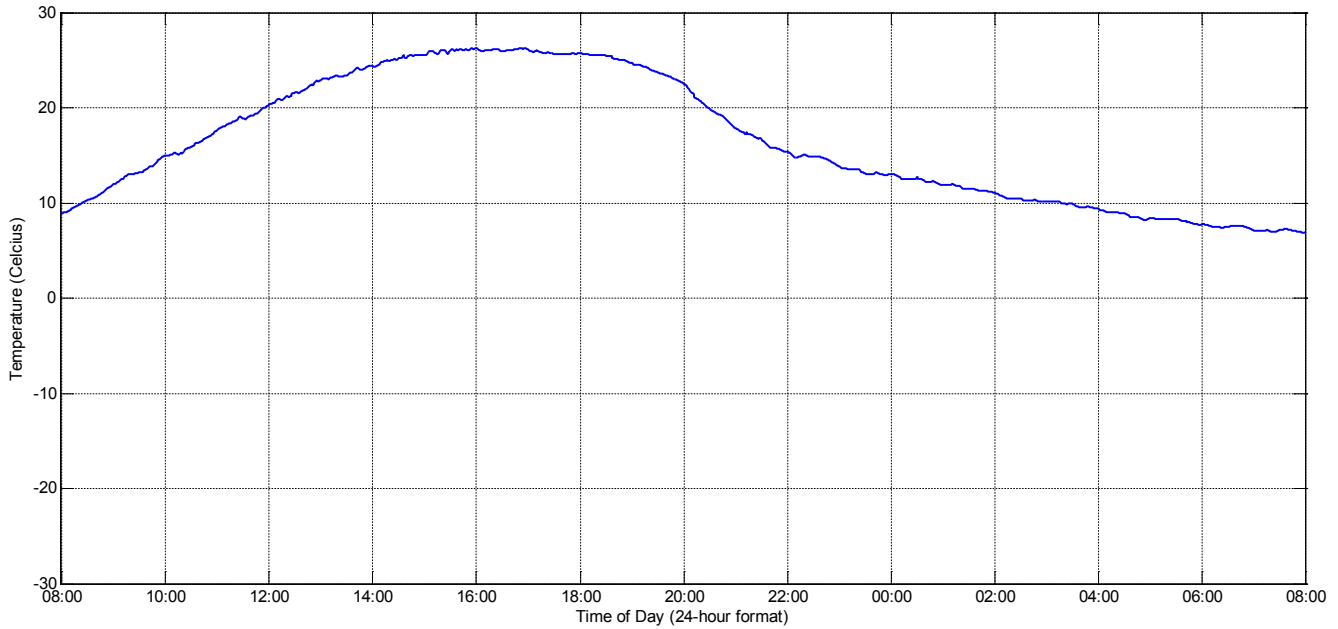
September 16 - 17, 2014 Monitored Temperature

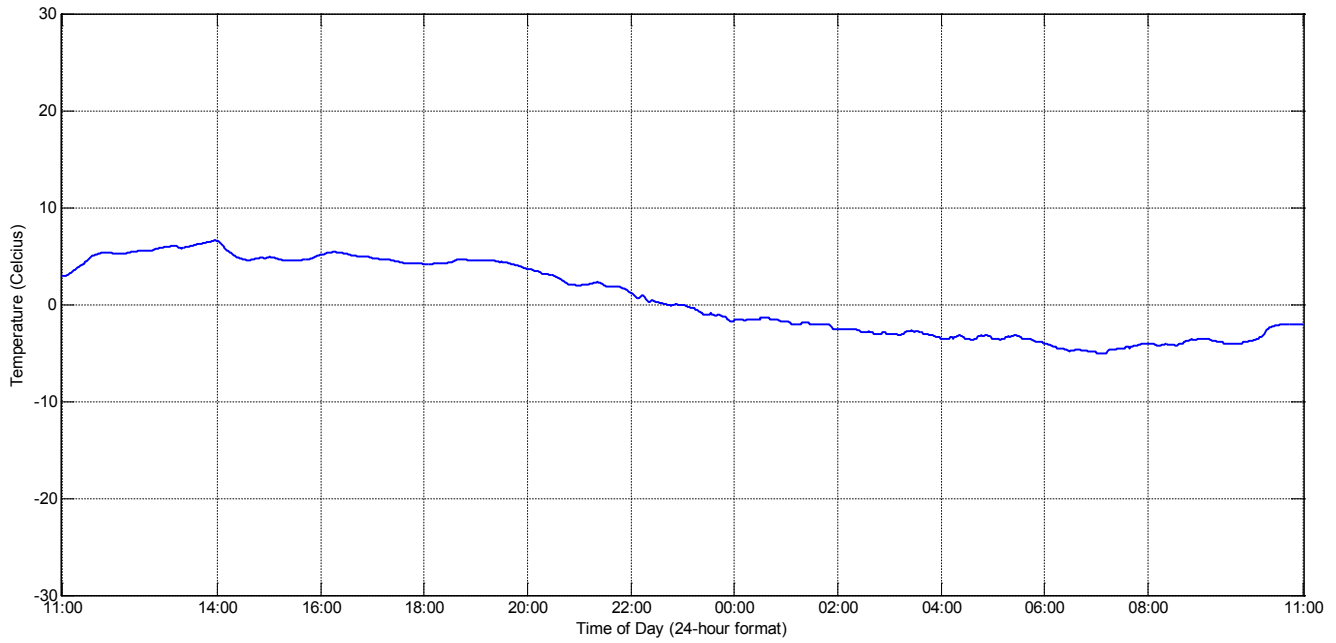
January 14 - 15, 2015 Monitored Temperature

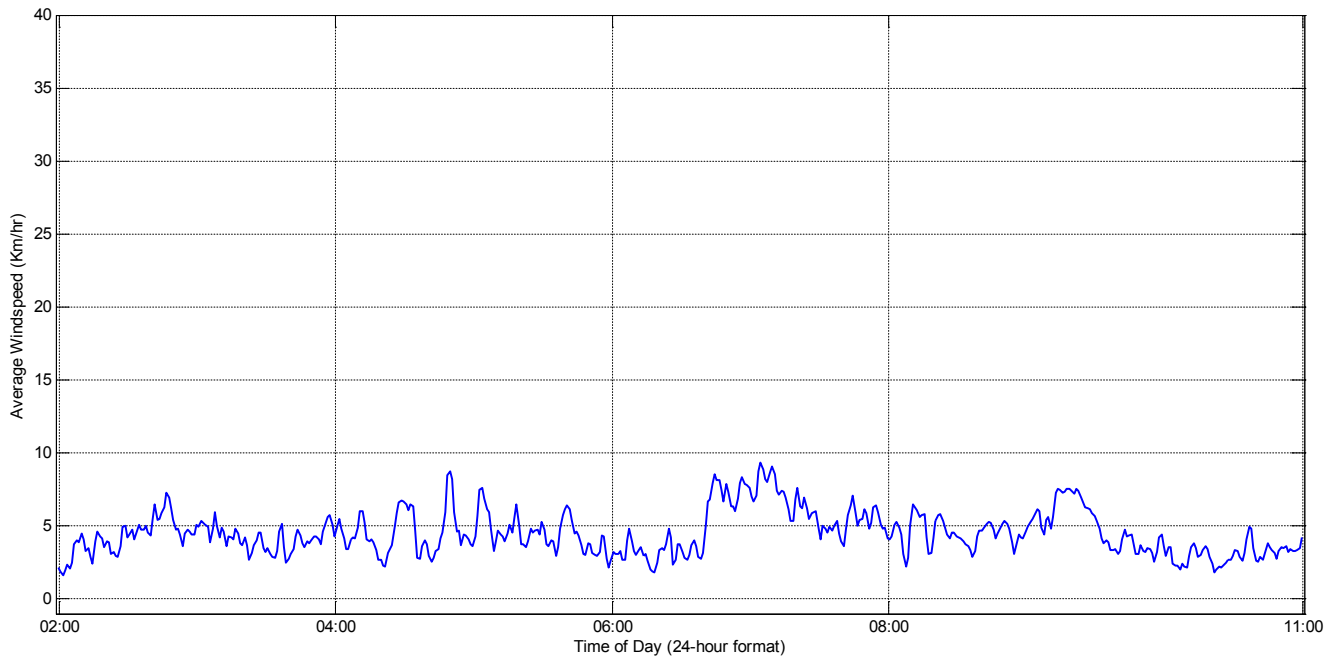
January 16, 2015 Monitored Wind Speed

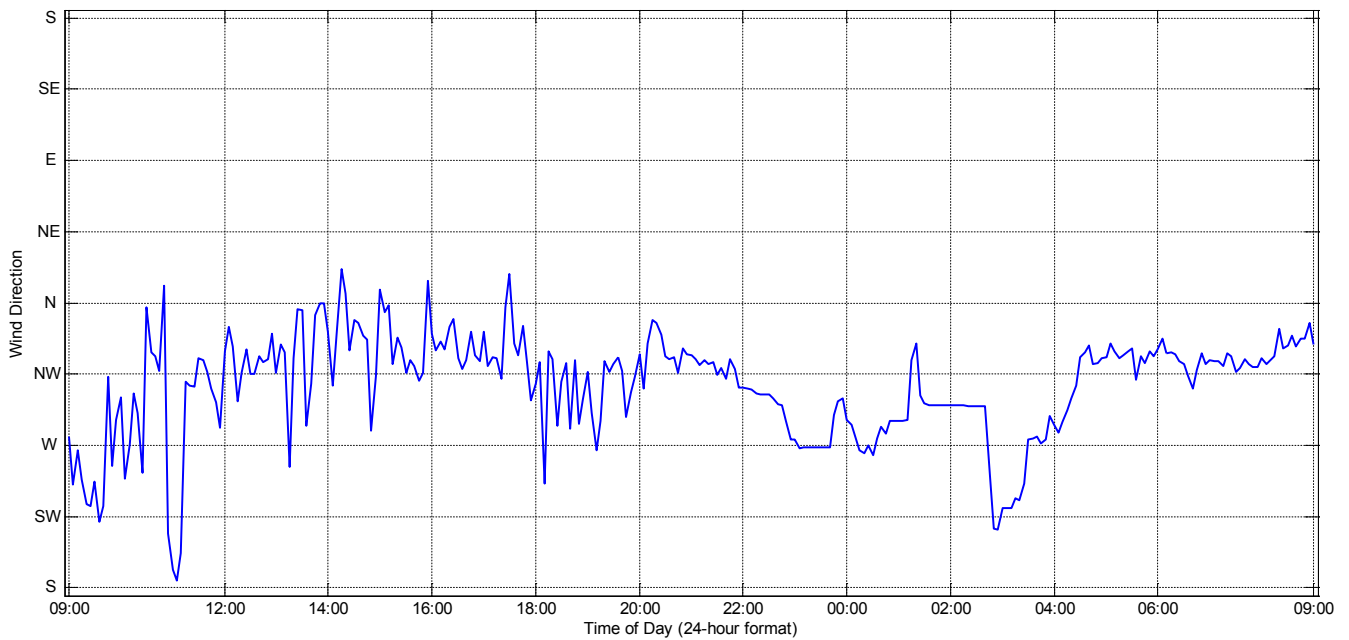
July 27 - 28, 2015 Monitored Wind Direction

During the *Summer, 2015* noise monitoring period, there was a full 24-hour time period with good weather conditions (i.e. generally light wind in the direction from 91 Street towards the noise monitors and no precipitation). The specific time period used was from 09:00 July 27 - 09:00 July 28. The detailed weather data obtained from the weather monitor during the time period discussed above is presented in [Appendix V](#).
